# D-250 HYDRAULIC UNIT REPAIR MANUAL

D-250 Hydraulic Unit Service  
VIN's 61-20RG01, 81-20RG01, 91-20RG01

HYDRAULIC UNIT AND PARTS IDENTIFICATION

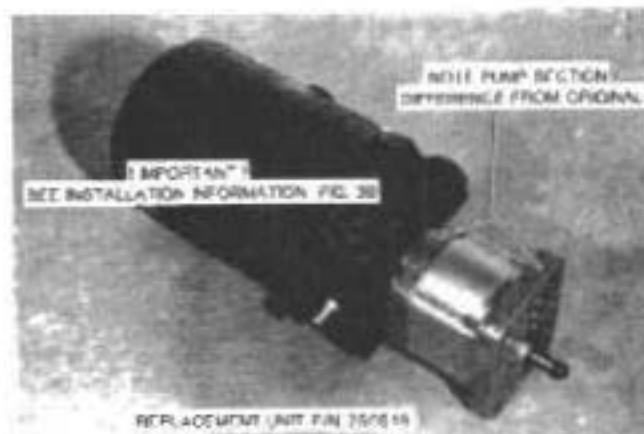
FIG. 3A. Replacement Single Hydraulic  
Unit, VIN 61-20RG01

REPLACEMENT UNIT SHOWN IN FIG. 3A  
IS LONGER THAN ORIGINAL — MODIFY  
SUPPORT BRACKET AS SHOWN

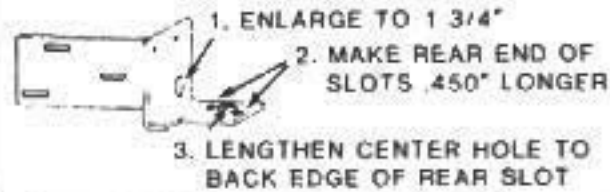
FIG. 3B. Bracket Modification.

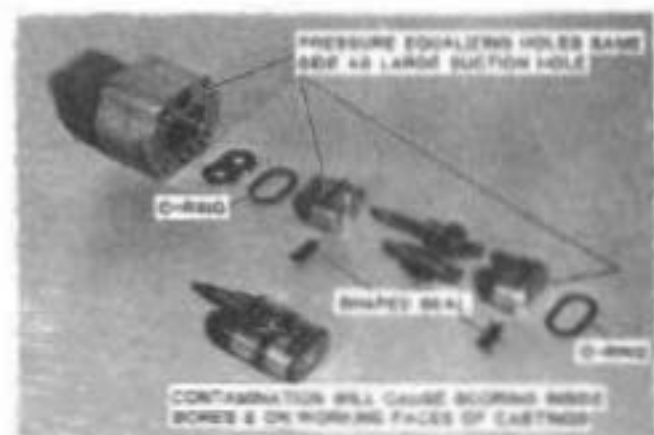
FIG. 11. Pump A1 Disassembled

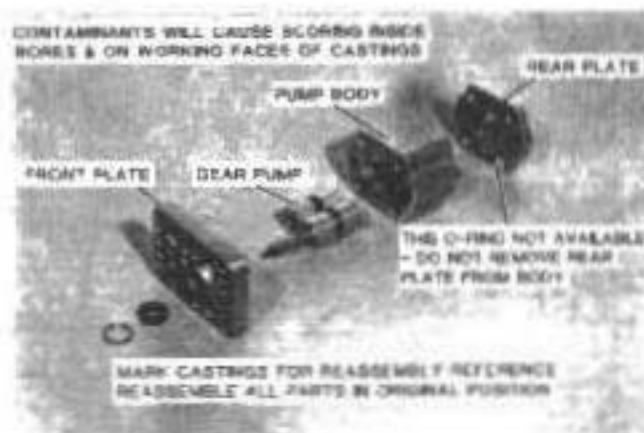
FIG. 12. Pump A2 Components

NOTE - Service this pump with one each 252318 & 252324. See Fig. 12 for location of unavailable O-ring.

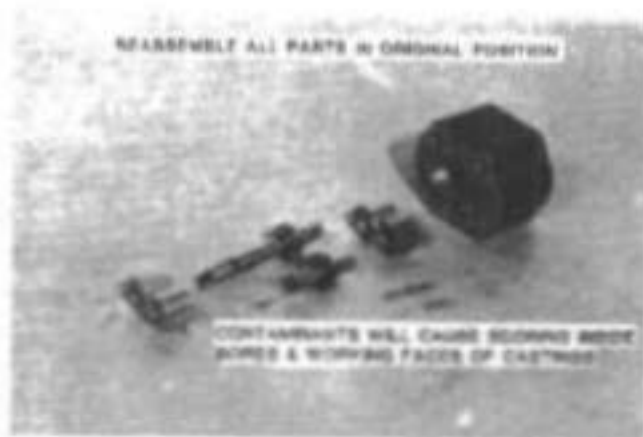
FIG. 16. Pump B1/Dual Hydraulic Pump Disassembled

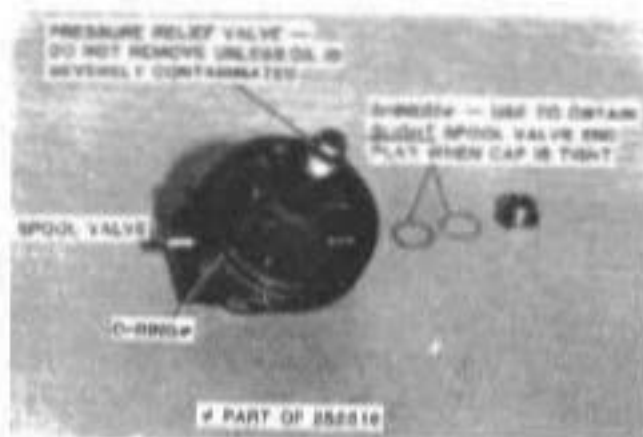
FIG. 17. Single Hydraulic Valve Body Assembly

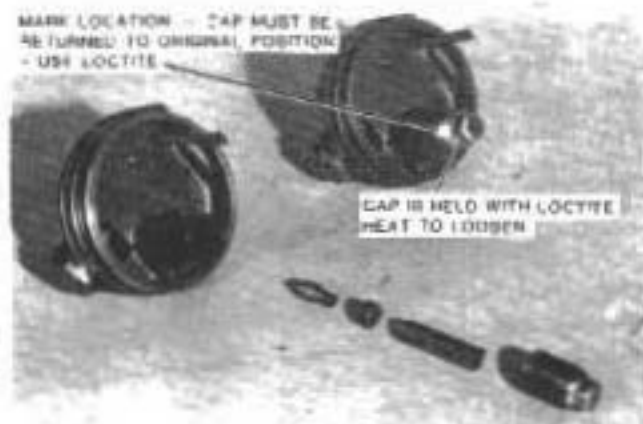
FIG. 19. Pressure Relief Valve

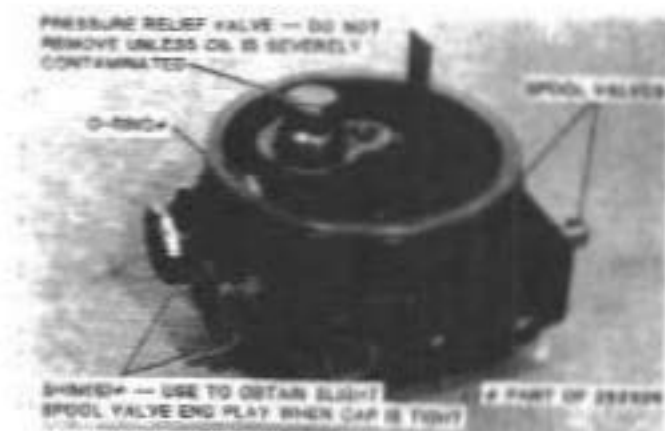
FIG. 20. Dual Hydraulic Valve Body Assembly

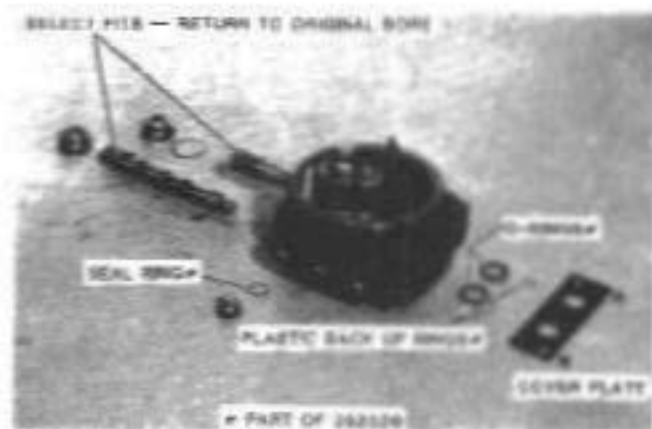
FIG. 21. Dual Hydraulic Spool Valves & Seals

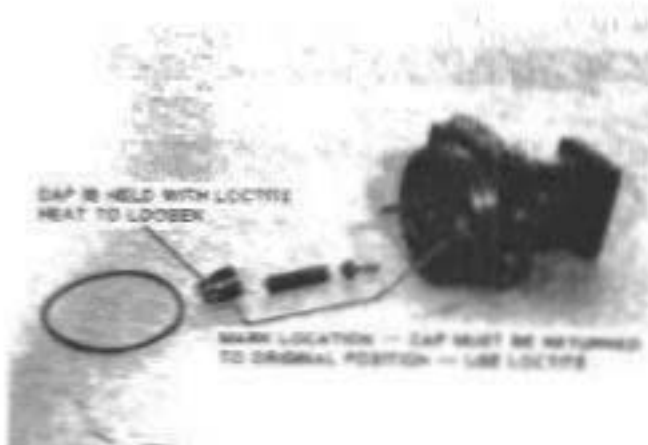
FIG. 22. Dual Hydraulic Pressure Relief Valve
